TESTING REPORT

报告编号: STD-20190426-014N

委托单位 Applicant	势泷 (上海) 流体科技有限公司 SEALLON (SHANGHAI) FLOW TECHNOLOGY CO.,LTD		
委托地址 Applicant Address	上海市金山区新顺路78号 NO.78 Xinshun Road, Jinshan District, Shanghai		
联系人 Contacts	杨洋 Chris Yang		
样品名称 Sample Name	齿轮箱 Gear box	样品编号 Sample Number	20190426-514001
型号/批号 Type/Serial No.	YZ-MY, 2019-04-18	样品数量 Sample Quantity	1 件 1pc
生产企业 Manufacturer	势泷流体科技 SEALLON FLOW TECHNOLOGY	其他信息 Other information	--
以上信息由委托单位提供, 并对其真实性负责 The above information is provided by the applicant and the applicant should answer for its authenticity.			
样品接收日期 Received Date	2019/05/06	样品状态描述 Sample State	完好 Intact
检测起止日期 Test Period	2019/05/06-2019/05/08	检测类别 Test Type	一般委托 Entrusted Test
检测项目 Test Item	外壳防护等级 (IPX8) Degrees of protection provided by enclosures (IPX8)		
检测依据 Test Standard	GB/T 4208-2017 外壳防护等级 (IP 代码) GB/T 4208-2017 Degrees of protection provided by enclosure(IP code)		
检测结论 Test Conclusion	依据标准共检 1 项, 外壳防护等级 (IPX8) 1 项符合测试要求, 检测结果见第 2 页检测结果汇总。 According to standard, the sample has been tested by 1 items of Degrees of protection provided by enclosures (IPX8) . The test results refer to page 2.

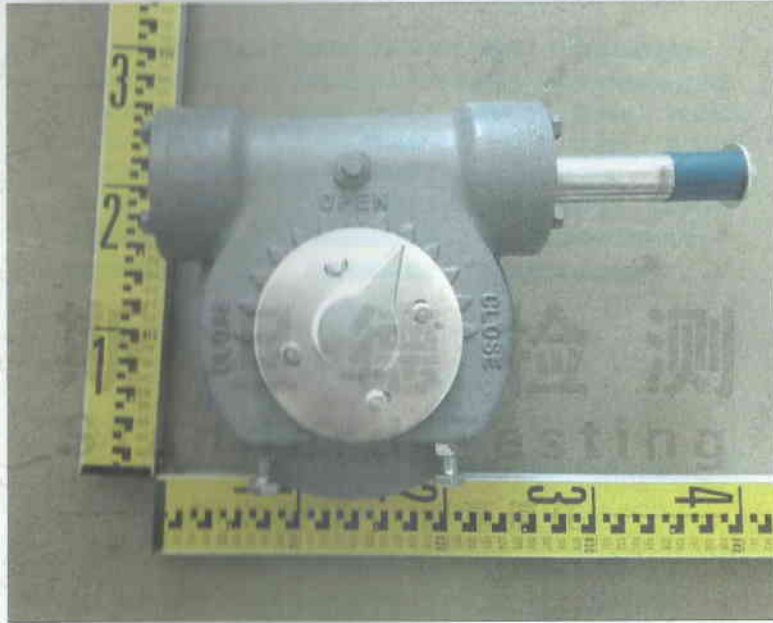
图 1.样品照片

Fig.1 The picture of sample
